# Restoring Resiliency in Lake Worth Lagoon

Palm Beach County

Department of Environmental Resources Management

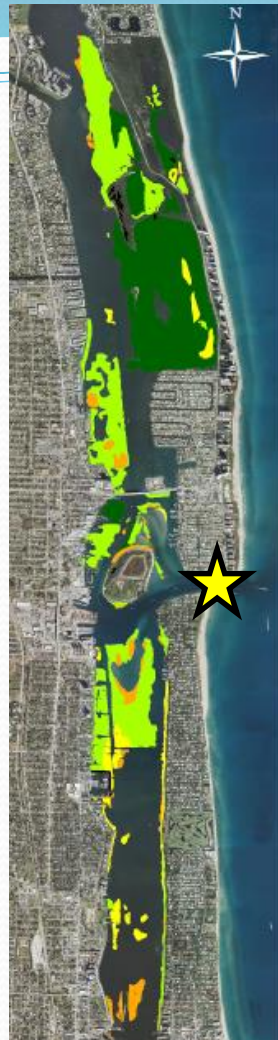
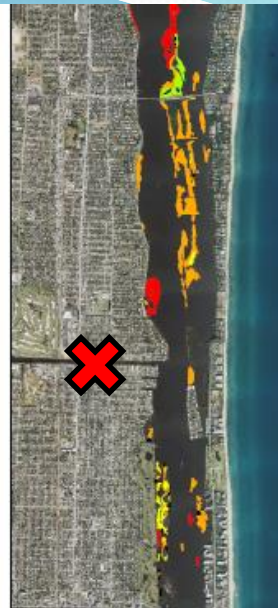
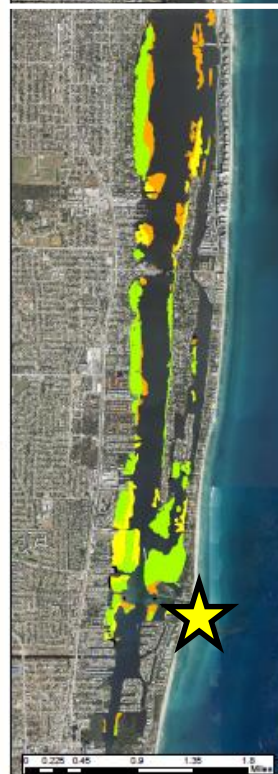
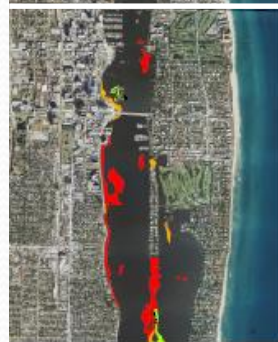
# 2013 Lake Worth Lagoon Seagrass Habitat Map

North, Central, and  
South Segments

## 2013 Seagrass Habitats

- Moderate to High Density Seagrass Habitat
- Low Density / Patchy Seagrass Habitat
- Zone of Seagrass Occurrence
- Unvegetated Potential Seagrass Habitat
- Unvegetated Softbottom (Central LWL)

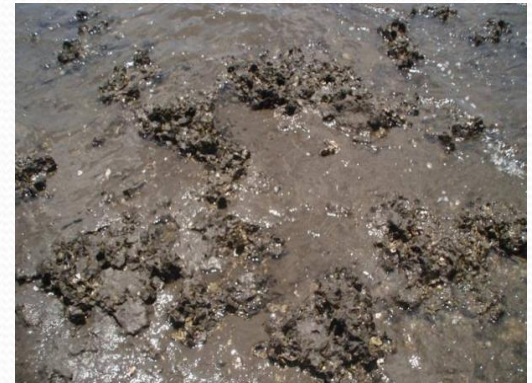
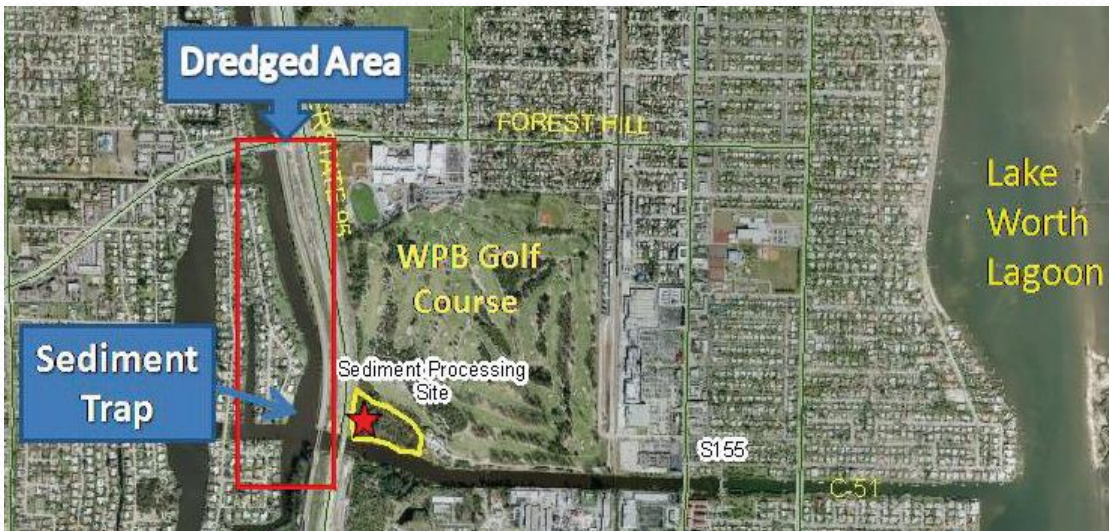
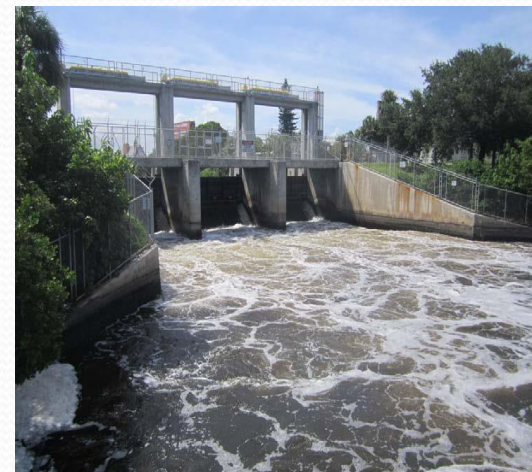
# Sediment Loading at C-51 Canal

Stormwater discharges carry:

- Nutrients
- Suspended sediments
- Organics

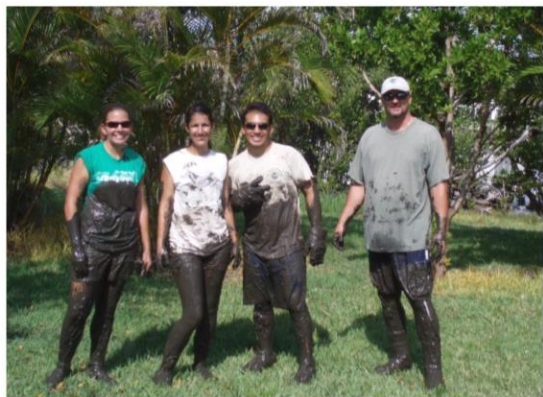
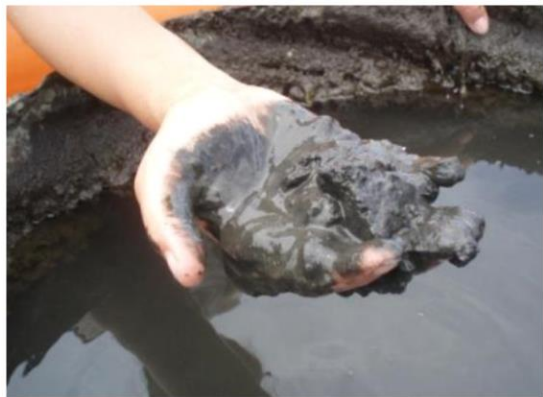
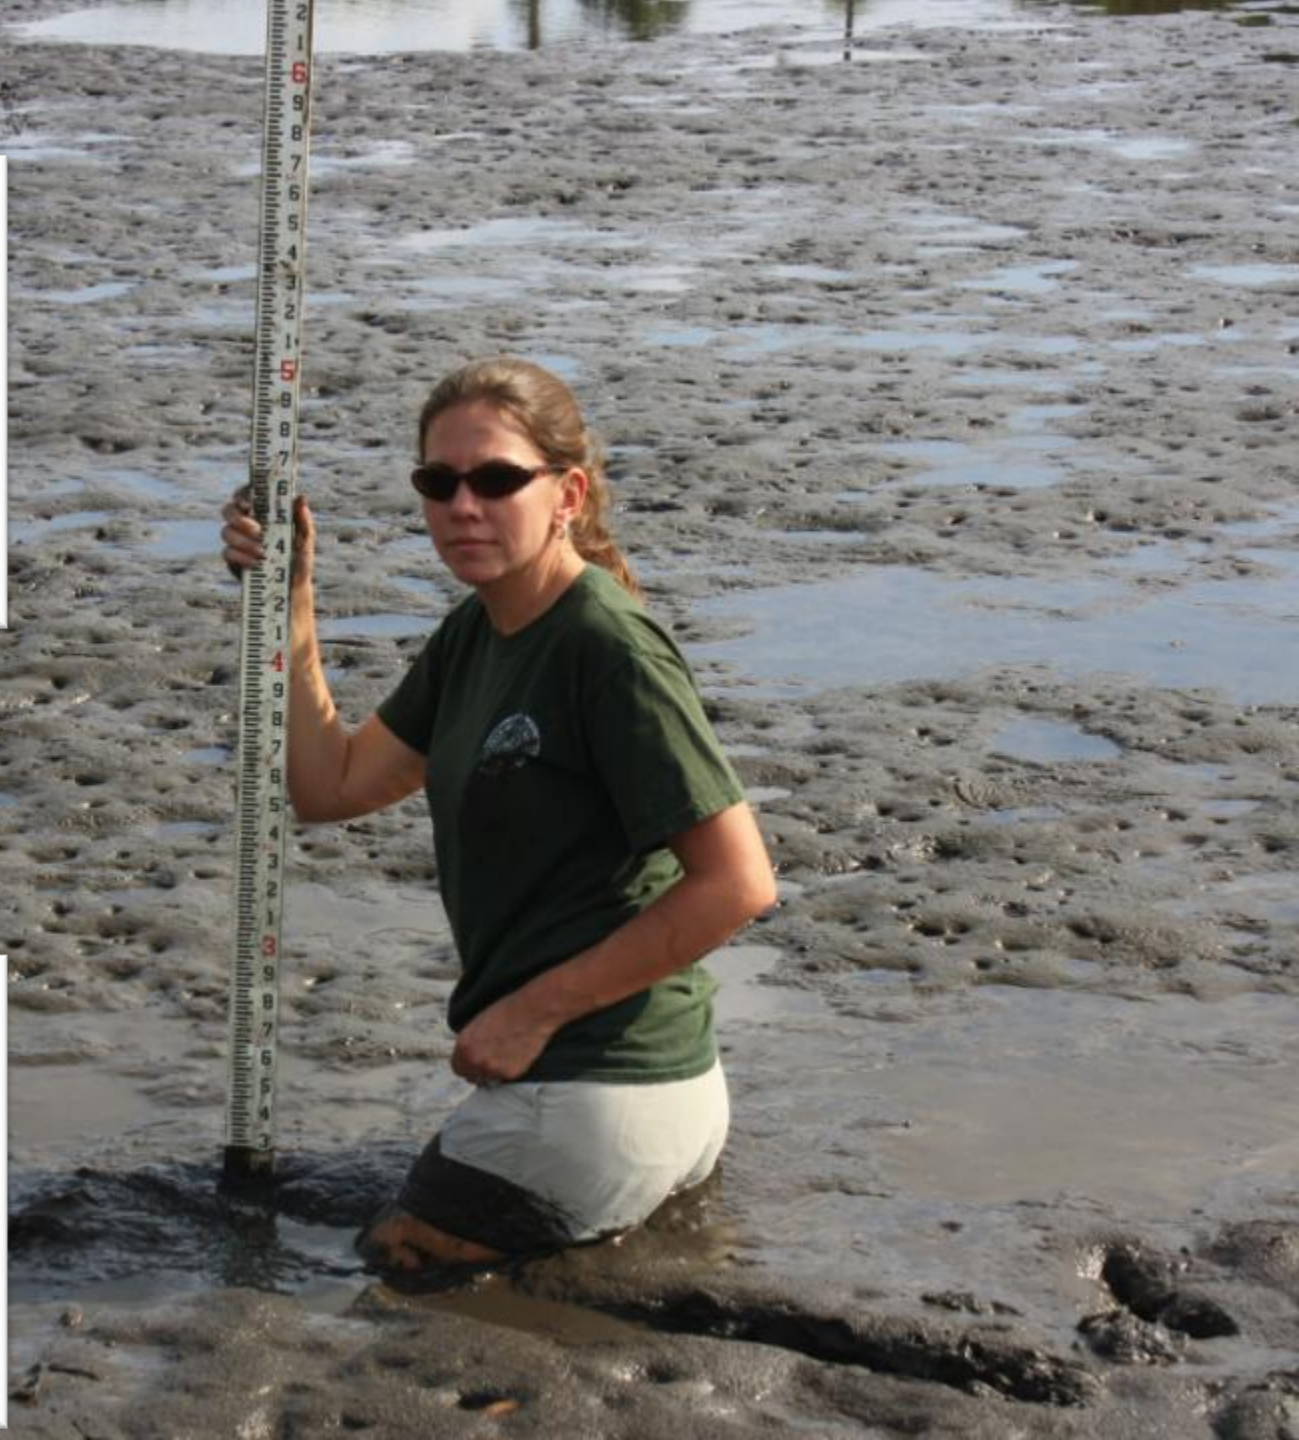
Elevation: NAVD 88

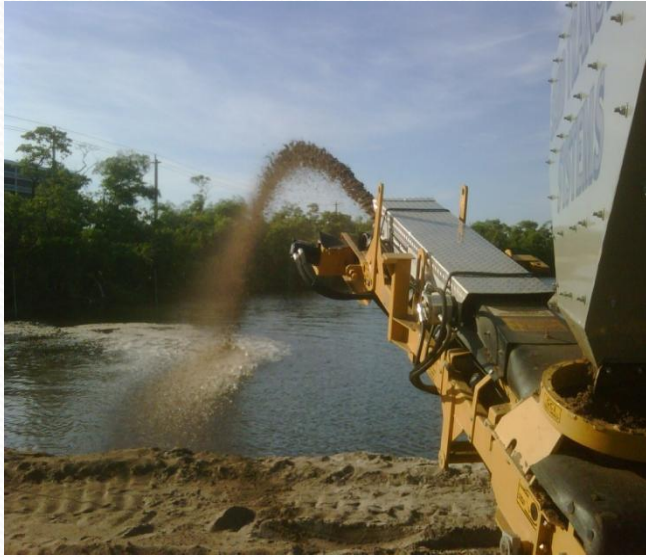
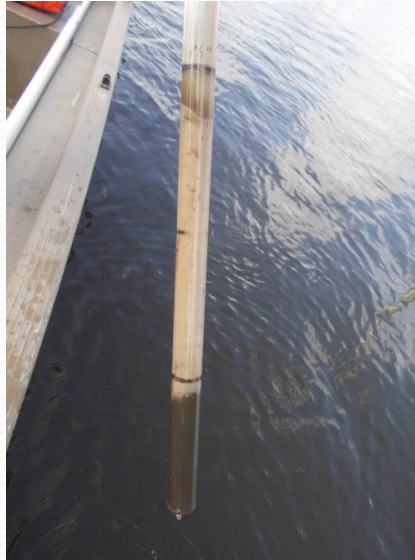
# Grassy Flats

- Sand Shooter
- Post-project core shows sand cap over muck
- Least terns
- American Oyster Catchers
